# On the Differential Displacements at the Base of the Van Nuys 7-Story Hotel During the January 17, 1994 Northridge Earthquake

Farzad Naeim, Ph.D., S.E., M.EERI\*

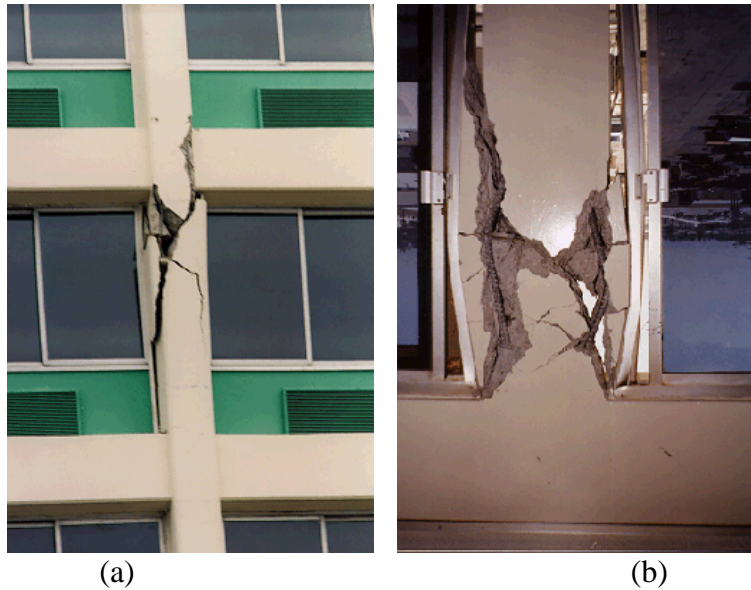
The building had suffered minor structural damage and extensive nonstructural damage during the 1971 San Fernando earthquake that was subsequently repaired. It experienced heavy damage during the 1994 Northridge earthquake where the South side exterior columns at fourth floor failed in shear (Figure 3).

Figure 3. Shear failure of column at the fourth floor  
(a) view from outside); (b) view from inside

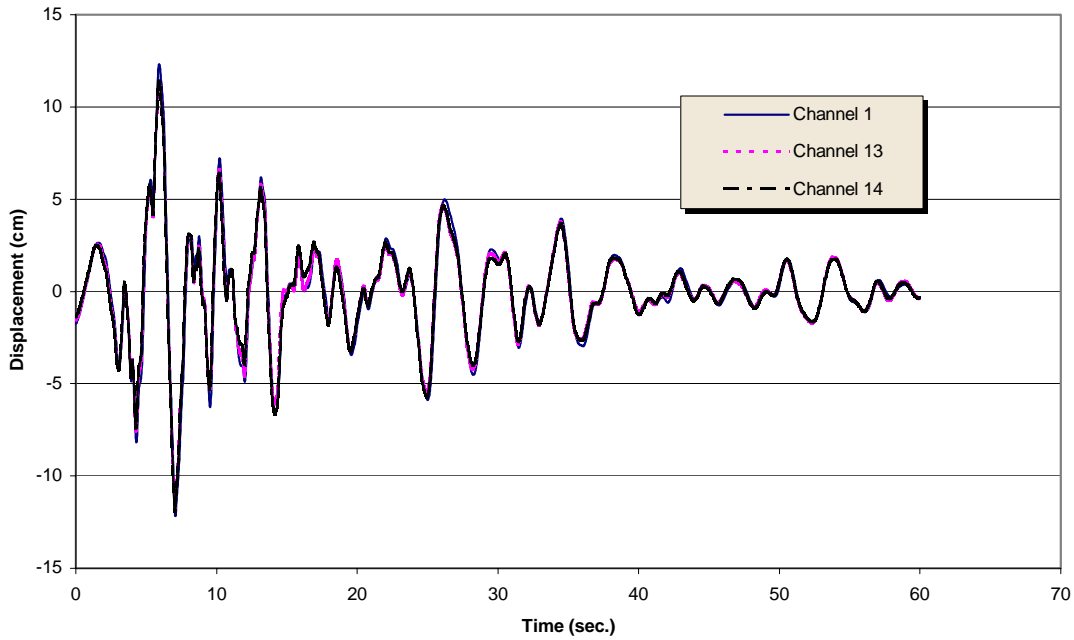
The displacements obtained by integrating acceleration records of sensors 1, 13, and 14 are shown in Figure 4. These displacement traces are perfectly in-phase and this nullifies spatial variation and phase lag as the causes of any differential motion. Furthermore, they exhibit identical frequency content. If we plot the difference in Channel 1 and Channel

Figure 4. Displacement traces obtained by integration of accelerations recorded at Sensors 1, 13, and 14.

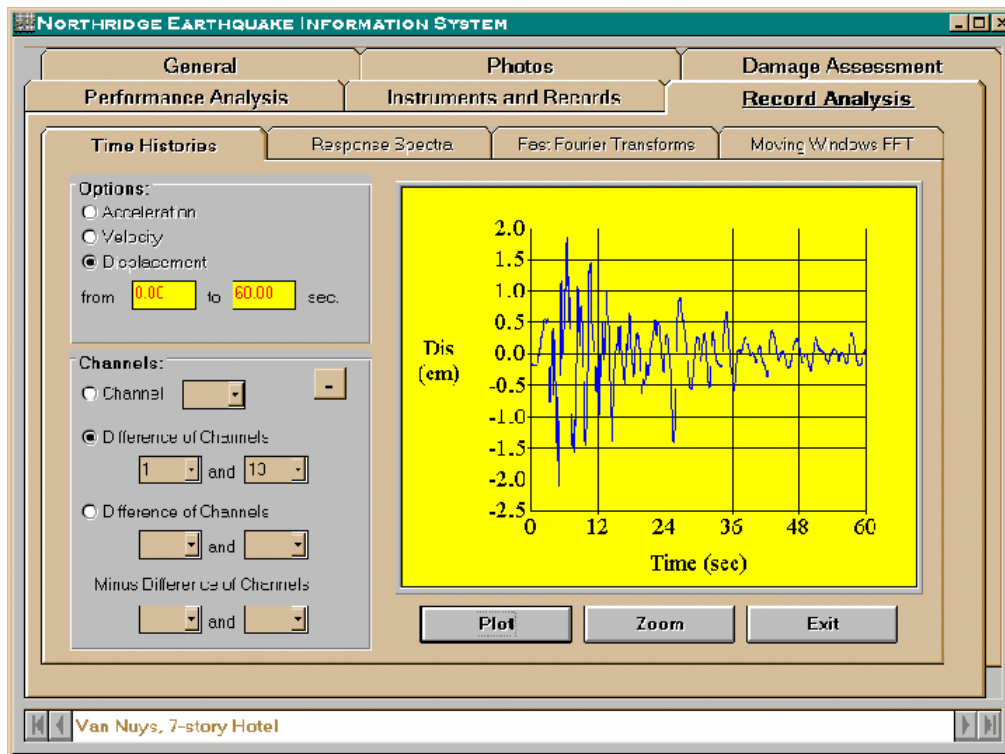
13 displacements (Figure 5), we notice a maximum difference of over 2cm (about 1 in). These differences are mainly in the amplitudes of in-phase peaks (Figure 6).

Figure 5. Difference of displacements between sensors 1 and 13.

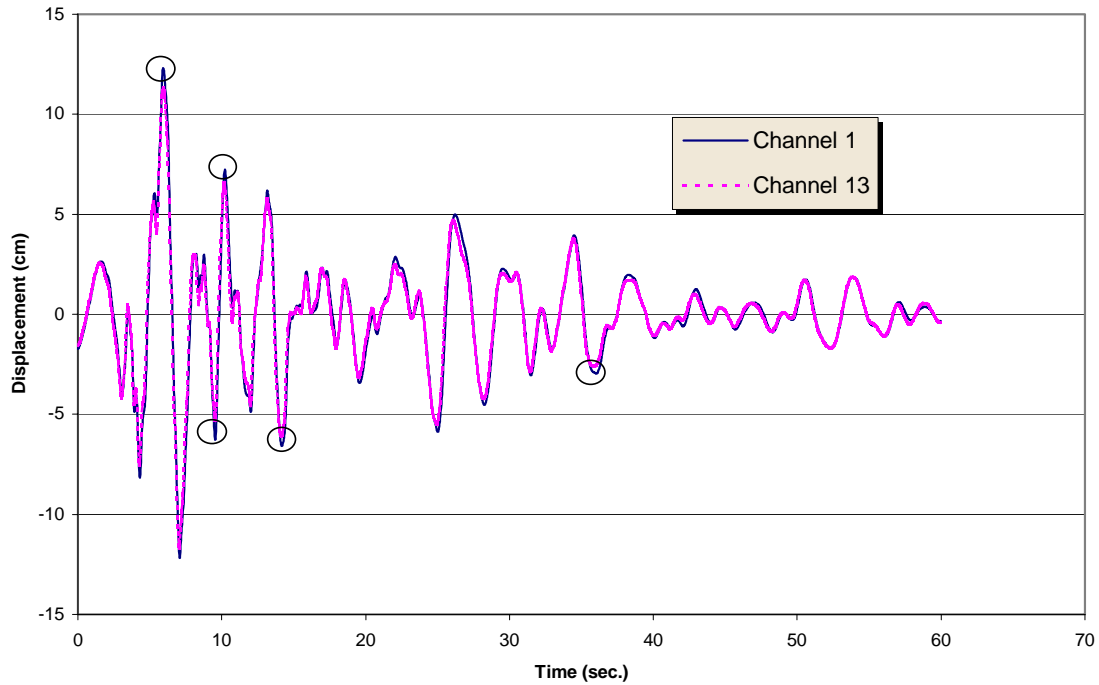
Figure 6. Displacement traces of Channels 1 and 13

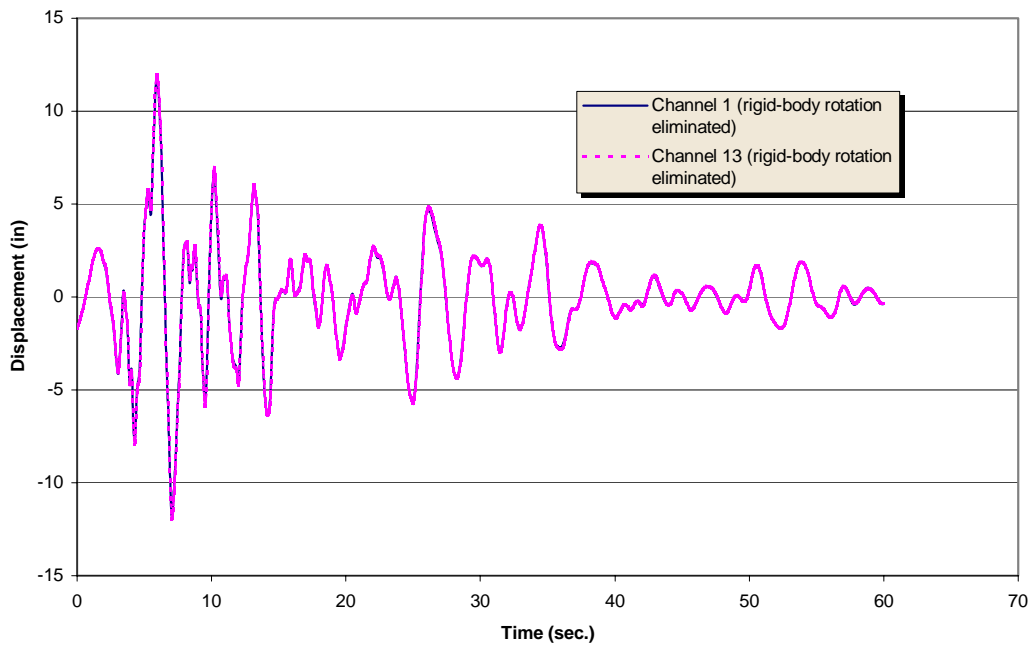
Now if we correct the displacement traces obtained from channels 1, 13 and 14 to eliminate rigid-body torsion obtained from the above equation, the difference in displacement of these channels is virtually eliminated (Figure 7).

Figure 7. Displacement traces of sensors 1, 13 match after removal of rigid-body rotation

The remaining difference of 0.6 cm (0.24 in) is easily explained by imperfect initial conditions of the displacement traces and the round off errors of finite sampling rate (50 samples per second). The initial displacements and their derivatives for neither trace is zero and non-equal to each other due to the missing front pieces of the accelerograms which have occurred before the accelerations have reached the level of triggering the sensors.
