A New Rigid Connection for Heavy Beams and Columns in Steel Moment Resisting Frames

***Farzad Naeim, Kan Patel and Kai-Chen Tu
John A. Martin & Associates, Inc.
Los Angeles, California***

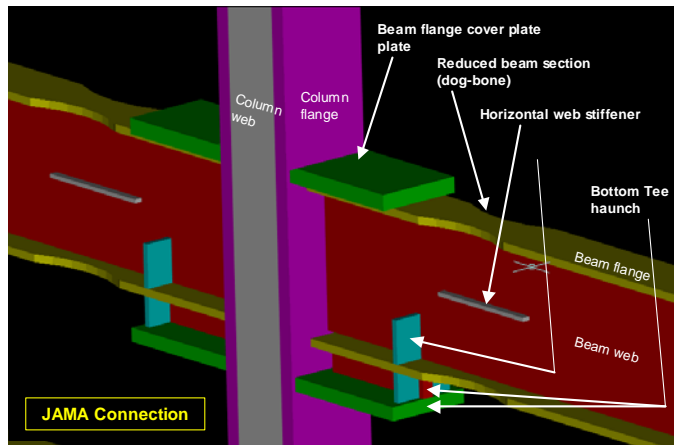
Figure 1. Illustration of the various components of a JAMA connection.

The connection configuration presented in this paper (the JAMA connection) is a hybrid solution which is particularly suited for large, drift-sensitive, projects utilizing heavy beam and column sections. It utilizes a variety of concepts including bottom haunch, top cover plate, beam web stiffener, and reduced beam section (RBS). In this connection, the cross section of the beam is intentionally reduced within a segment to produce an intended plastic hinge zone. Contrary to conventional RBS solutions, the reduced section in JAMA connection is placed within the beam span away from the column face. The beam section between the reduced section and the face of the column is reinforced with a bottom haunch and a top cover plate in order to substantially reduce the seismic demand at the face of the column. The buckling of the web at the plastic hinge region is effectively postponed via the application of horizontal beam web stiffeners as shown in Figure 1.

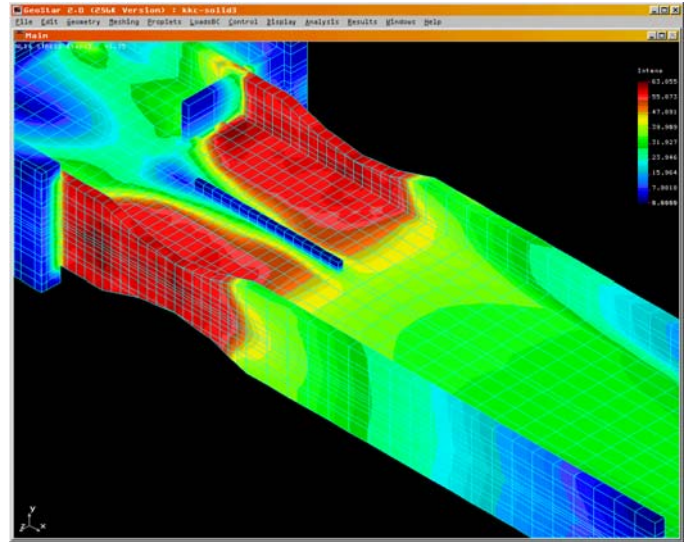
Figure 2. Von-Mises stress contours at full plastification of the RBS according to the pre-test finite element model (Naeim, 1999).

Detailed analytical validations of the proposed concept were performed using nonlinear finite element analysis techniques (see Figures 2 and 3) utilizing two independent computer programs namely COSMOS/M

Both computer models used nonlinear solid elements but utilized different finite element meshing and nonlinear

solution scheme strategies. The results of both analyses confirmed the validity of the concept. The first set of analyses provided guidance for the refinement and adjustment of various components of the connection which were implemented before a set of full-scale cyclic tests were conducted at the University of Nevada, Reno. The second set of analyses were conducted following the experimental studies to further calibrate results of analysis with those observed from full-scale testing. Due to space limitations, in this paper we concentrate on the experimental results.

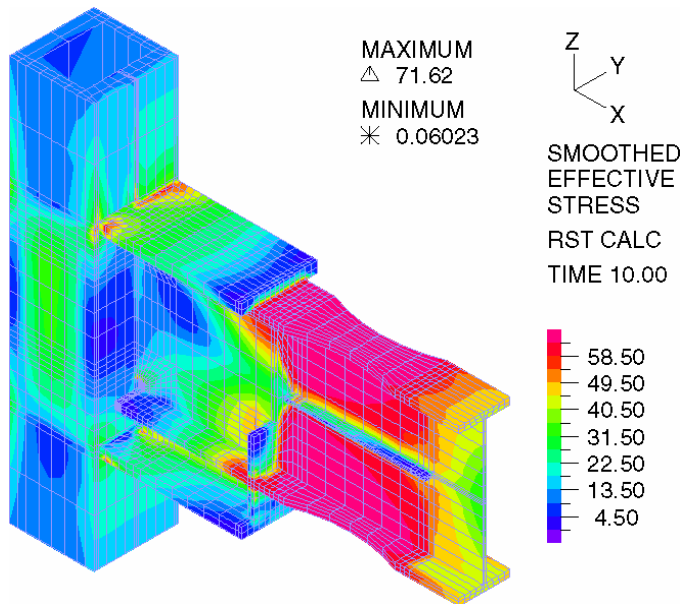
Figure 3. Smoothed Effective stresses at full plastification of the RBS according to one of the post-test finite element models (Anderson, Xie, and Naeim, 2001).

The actuators were attached to three 8 ft. x 4 ft. x 4ft. reaction blocks and to the actuator guide as shown in Figure 4. The guide was attached to the beam through a 3½ in. diameter pin. The column was attached to two brackets as shown in Figure 3 to resist the axial force and the shear applied at its supports. Bracket A was attached to two reaction blocks while bracket C was attached to three reaction blocks.

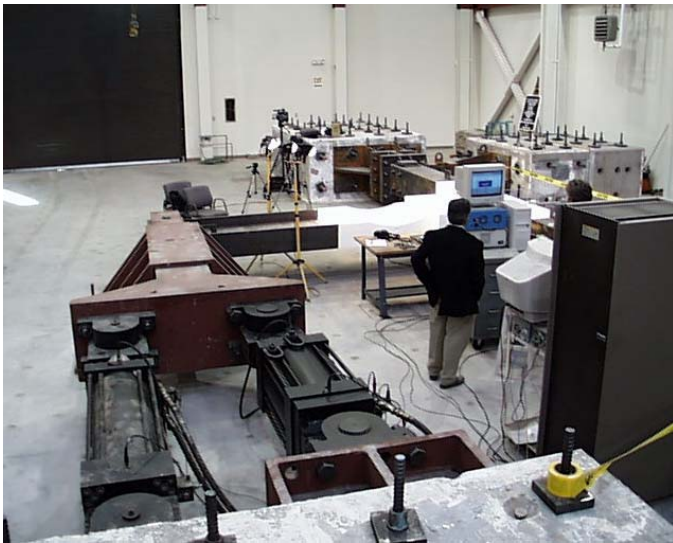
Figure 4. The laboratory setup for testing.

Three full-scale test specimens were tested under large cyclic deformations. The first specimen consisted of W36x232 beam and built-up box shape column 20"x20"x4"x2". The second and third specimens, identical specimens, consisted of W40x362 beam and built-up box shape column 24"x24"x4"x2". The first, second, and third specimens are designated as specimen 36-1, 40-1, and 40-2, respectively. A photo of the laboratory setup prior to testing is shown in Figure 4.

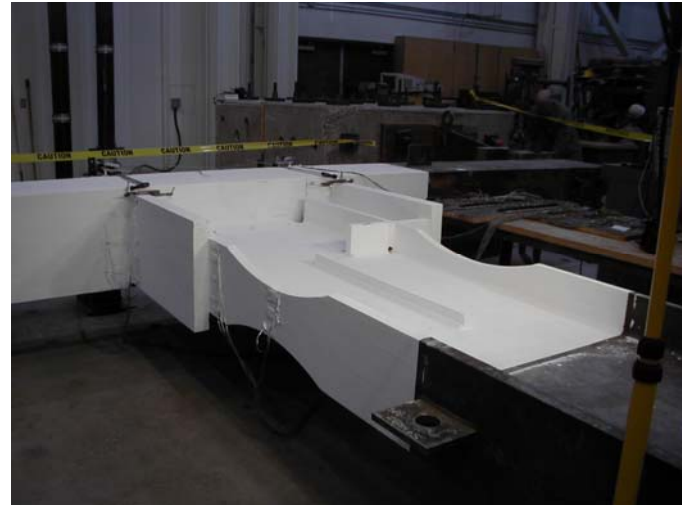
Figure 5. The 36-1 specimen in place ready for testing. The areas of concern are whitewashed to show possible signs of distress.

surface roughness was specified to meet the requirements of AWS C4.1-77 Class 4. All corners were rounded to minimize any notch effects. A horizontal web stiffener 1"x2"x3'-0" was added at web mid-height at each side of the web to delay web local buckling. More details of a typical test specimen are shown in Figures 5 to 9, respectively.

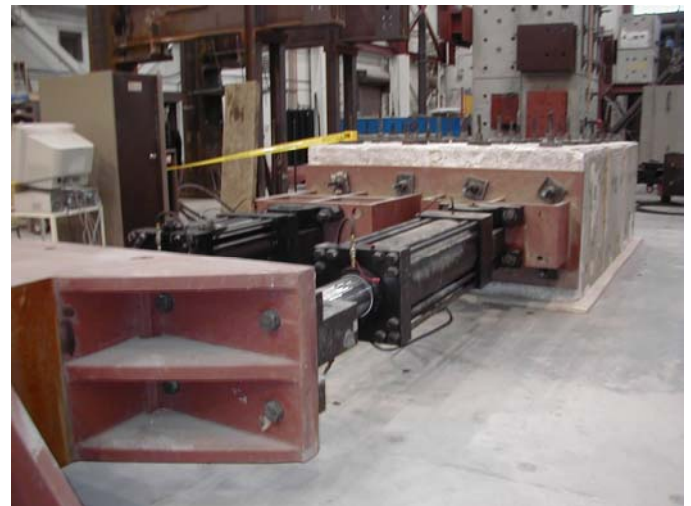
Figure 6. The two actuators used in series to force cyclic displacement at the end of the beam.

The lateral actuators, MTS model 243.80 and 243.90, were under displacement control. The two actuators combined were able to apply 650 kips and ± 9 in of movement in each direction. No lateral bracing of beam flanges were provided except at the actuator location. The Inspector of Record monitored all the tests, while OSHPD representatives witnessed the second and the third tests.

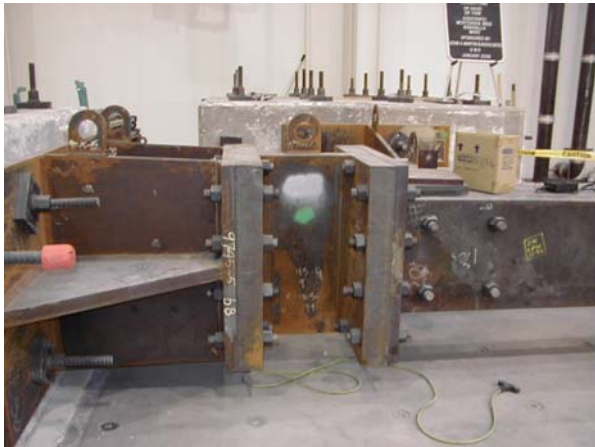
Figure 7. The column ends are restrained by attachments to the resistance block.

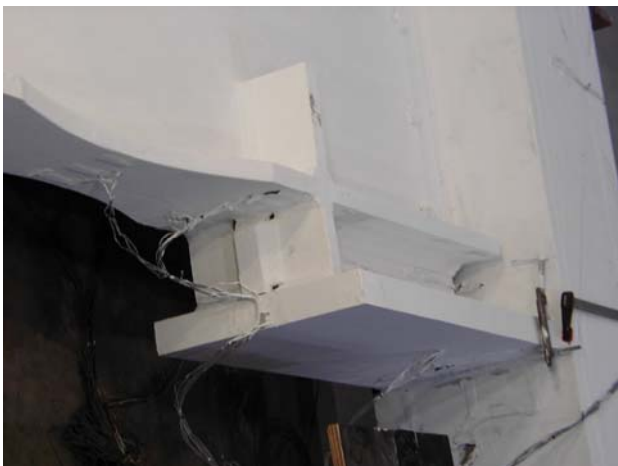
Figure 9. Whitewashed and instrumented bottom RBS and haunch.

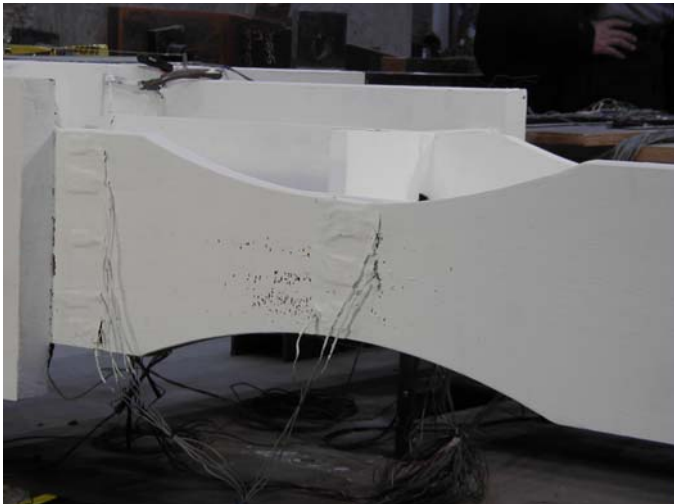
Figure 10. The onset of yielding of Specimen 36-1 at $\delta = \delta_y = 1.5$ in.

Photos taken from various stages of testing of this specimen are presented in Figures 10 to 16. The force-displacement characteristics of specimen 36-1 are shown in Figure 17 where the horizontal axis represents the lateral displacement applied at the pin and the vertical axis represents the shear applied by the two actuators. Initial yielding occurred during cycles 7 and 8 at $\delta_y=1.5$ inches. The yielding was observed at RBS of both flanges. Progressing through the loading history, yielding started to propagate along the RBS. During cycle at $4\delta_y$ (4.1% plastic rotation) initiation of web buckling was noted on both sides of the top and bottom flanges. With the increasing of the displacement the web started to experience serve local buckling and initiation of plastic local buckling in the flanges. The web buckling and the significant yielding of the flanges limited the capacity of the beam. It should be noted here

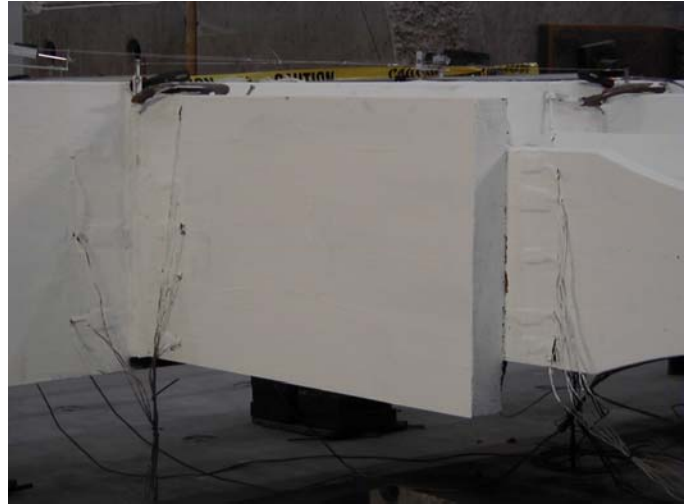
Figure 11. As predicted by our nonlinear finite element analysis (Naeim, 1999), at low amplitude cycles there would be some rise in stress along the tip of the cover plate that would subside as the specimen would go into nonlinear range. That is exactly what happened. This picture is taken at yield displacement.

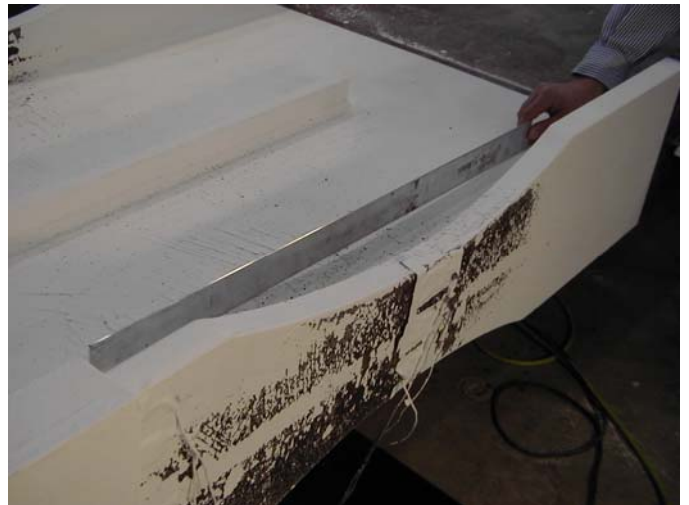
Figure 12. Specimen 36-1 at displacement of $2\delta_y$. Yielding of RBS flange is extended and signs of web buckling above the web stiffener may be seen.

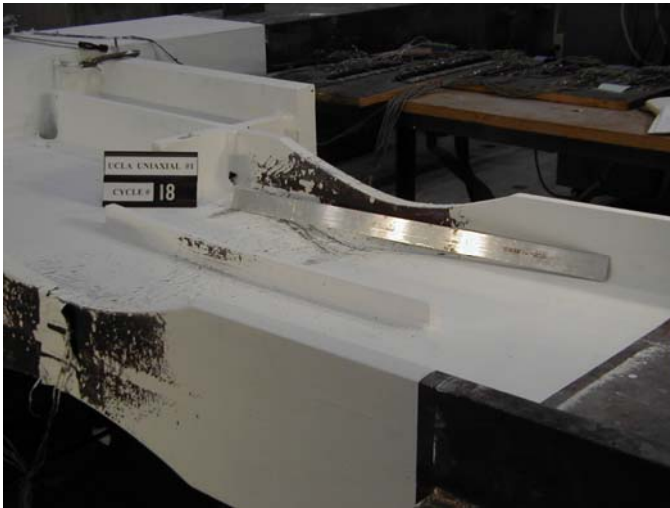
Figure 13. At the end of $3\delta_y$ cycles or 2.7% plastic rotation web buckling may be observed, but no strength reduction is yet noticed (photo of specimen 36-1).

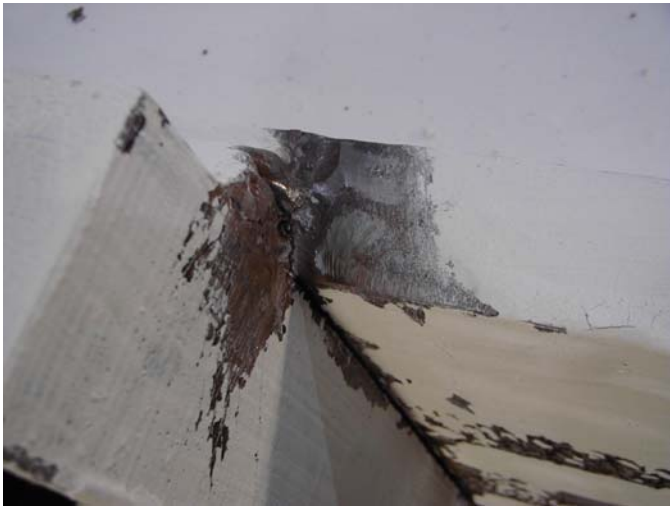
Figure 14. At $3\delta_y$ a crack at the tip of the beam flange at the termination of cover plate was observed in all three specimens. This crack however did not grow in size or length during the remaining cycles of the test and did not adversely affect the hysteretic characteristics.

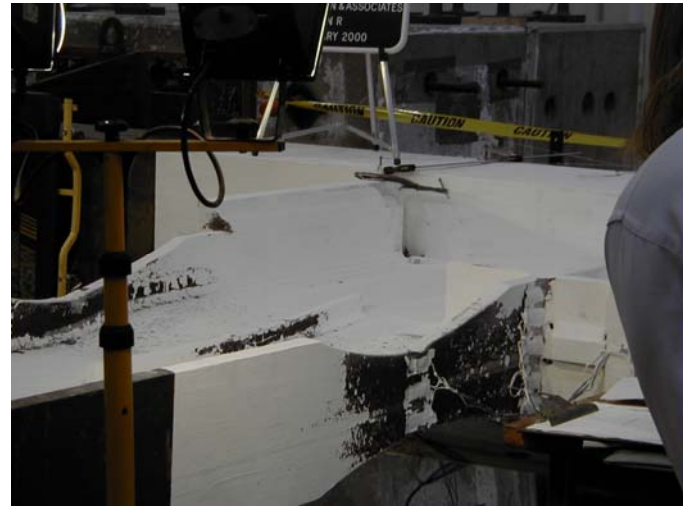
Figure 15. At the end of regulatory testing or 4% plastic (6.8% total) the specimen (36-1 showed here) is still showing increasing capacity and no loss of stiffness is present. Plastification of RBS flanges, buckling of the beam web and some local buckling of the RBS flange may be observed.

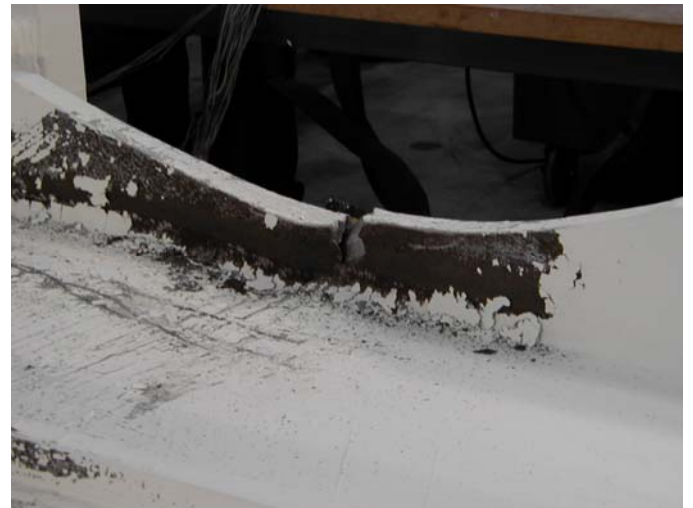
Figure 16. Finally, at $5\delta_y$ (5.4% plastic rotation, 6.8% total rotation) failure of 36-1 specimen starts by tension failure of the bottom flange at the center of RBS and propagates into the web. Specimens 40-1 and 40-2 stayed course as the actuators ran out of stroke at plastic rotations exceeding 7%.

During the second cycle at $6\delta_y$ (6.8% plastic rotation) a crack was developed in the middle of RBS bottom flange. Upon progressing through the loading history, the crack spread rapidly across the bottom flange and propagated through the web. Due this fracture the lateral load capacity started to deteriorate as can be seen in the hysteresis loops. The test was stopped because of the severe deformation of the specimen and the significant drop in the lateral capacity. The maximum force that the specimen was subjected to was 378 kips.

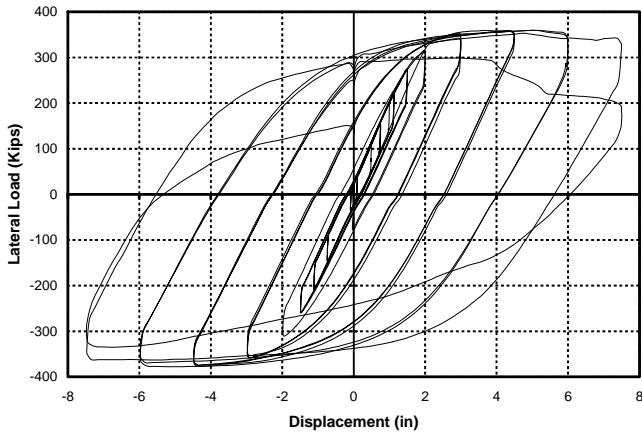
Figure 17. Force-displacement response of specimen 36-1.

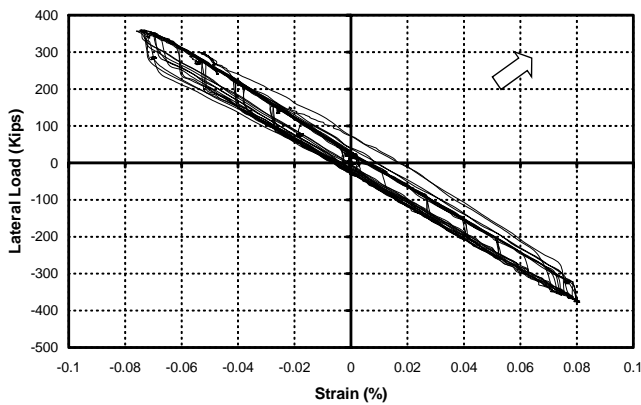
Figure 18. Strain data of panel zone rosette of specimen 36-1.

There were no signs of yielding in the column. The column panel zone stayed in the elastic range as the white wash stayed intact. The readings of the 45/90 rosette, mounted in the middle of the column panel zone, is shown in Figure 18. As can be seen from this figure, the strains were well below the yield strain indicating that the column web zone stayed in the elastic range. The maximum ratio of the shear deformation to the total deformation was 3.3%. Therefore, contribution of panel zone distortion to the deformation of the assembly was negligible and the panel zone could be assumed fully rigid for design calculations. This fact was further confirmed by post-testing nonlinear finite element analyses (Anderson, Xie, and Naeim, 2001).

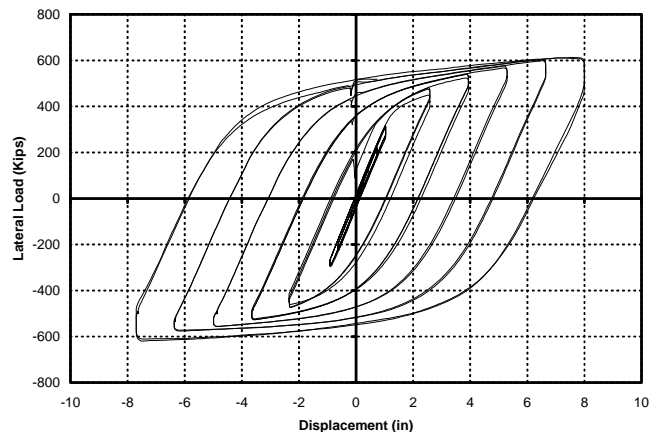
Figure 19. Force-displacement response of specimens 40-1 and 40-2.

Specimens 40-1 and 40-2 were identical specimen and showed similar behavior during the cyclic testing. The response of specimen 40-2 is shown in Figure 19. Initial yielding occurred during cycles 7 and 8 at $\delta_y=1.3$ inches. Progressing through the loading history, the yielding started to spread across the RBS at both top and bottom flange. The process of plastification was characterized by propagation of the yield pattern along the beam flanges and by yielding of the beam web. The energy dissipated is reflected by wider hysteretic loops. The ultimate resisting force of the specimen was 620 kips. During the 4 δ_y cycle (3.6% plastic rotation) plastic local buckling started to occur in the web. This local buckling did not cause any deterioration of the load capacity as can be seen in the hysteresis plot.

At this stage of the test, the regions in the specimen away from the plastic zone were carefully inspected for signs of yielding and damage. Several local yield lines were observed in a region adjacent to the RBS, however yielding was not observed adjacent to the beam-column connection. Increasing the deformation demand was accompanied by a minor plastic local buckling in the flange RBS zone. Two cycles of displacement at $7 \delta_y$ corresponding to the maximum stroke of the actuators did not cause failure in specimen 40-1 and the test was stopped at that point. The same results were obtained for specimen 40-2. This time, however, the cycles were repeated till failure of the specimen occurred by local buckling of the flange at the reduced section which finally led to a crack. The flange then started to tear across its thickness and propagating through the flange causing a drop in the lateral capacity.

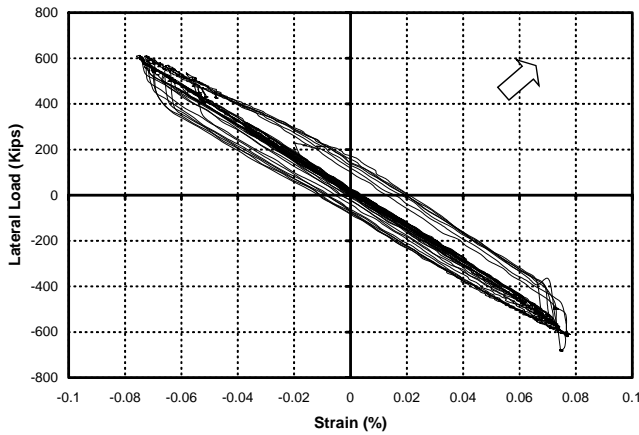
Figure 20. Strain data of panel zone rosette of specimen 40-2.

There were no signs of yielding in the column. The column panel zone stayed in the elastic range as the white wash stayed intact. The readings of the 45/90 rosette, mounted in the middle of the column panel zone, are shown in Figure 20. As can be seen from this figure, the strains were well below the yield strain indicating that the column web zone stayed in the elastic range. The maximum contribution of shear deformation to total deformation was about 3.4%.

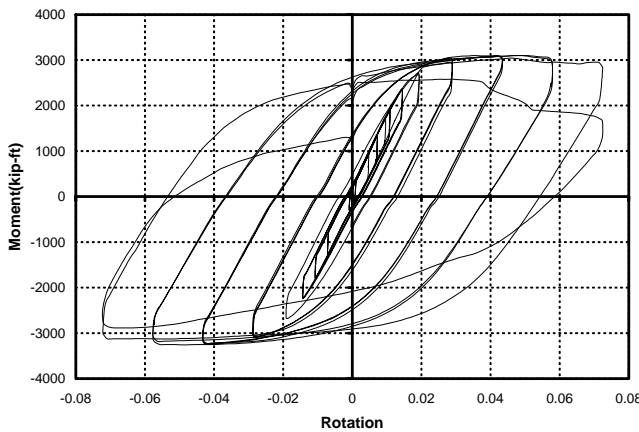
Figure 21. Moment-rotation response of specimen 36-1.

The total-moment rotation plots for the specimens are presented in Figures 21 and 23. The moment in these

plots is defined as the shear force as applied by the actuators multiplied by the centerline distance of the pin from the middle of the RBS. The rotation is defined as the lateral displacement at the pin divided by the centerline distance of the pin from the middle of the RBS. The value of the rotation defined in this way includes contribution from both elastic and inelastic deformation. A response of greater interest than the total rotation is the plastic rotation, θ_p . The plastic rotation was computed for the specimens as follows

As can be seen from these figures, specimen 36-1 reached almost 6% radians of plastic rotation, while specimen 40-2 exceeded 5% radians of plastic rotation.

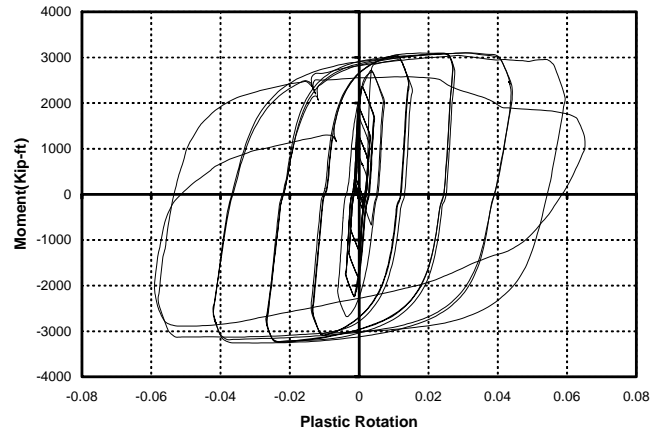
Figure 22. Moment-plastic rotation response of specimen 36-1.

$$\theta_p = \theta - \frac{V}{K_e}$$

where V is the shear force and K_e is the ratio of V/θ in the elastic range. Figures 22 and 24 show the moment versus the plastic rotation of specimens 36-1 and 40-1/2.

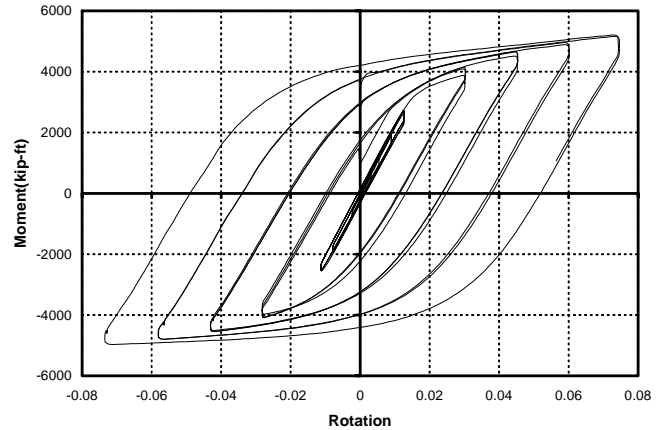
Figure 23. Moment-rotation response of specimens 40-1 and 40-2.

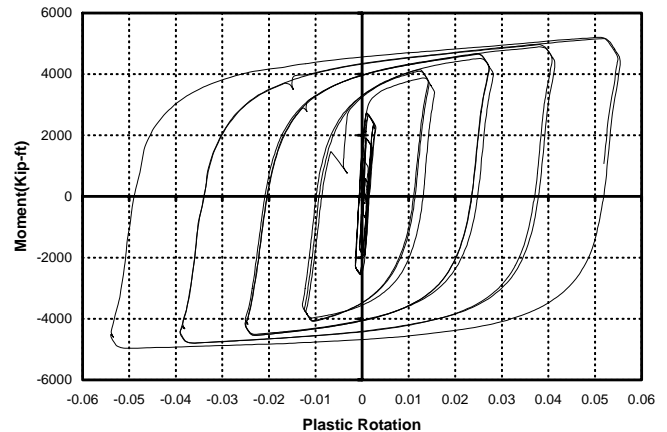
Figure 24. Moment-plastic rotation response of specimens 40-1 and 40-2.

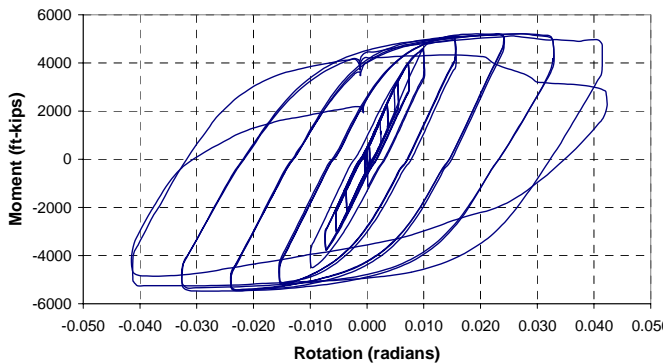
Figure 25. Moment-plastic rotation response of specimen 36-1 (rotation measured from the centerline of the column).

The moment-plastic rotation responses of the smaller and larger specimens as measured from the centerline of the column are presented in Figures 25 and 26, respectively. Calculations showing that the tested specimens passed this requirement are summarized below:

- W36: $\theta = 0.025 \left[1 + \frac{(L-L')}{L'} \right] = 0.025 \left[1 + \frac{(174.00-109.75)}{109.75} \right] = 0.0396$
- W40: $\theta = 0.025 \left[1 + \frac{(L-L')}{L'} \right] = 0.025 \left[1 + \frac{(174.00-103.50)}{103.50} \right] = 0.0420$

- W36: $\theta = \frac{(\delta_{total} - \delta_y)}{\left(\frac{L}{2}\right)} = \frac{[6(1.5) - 1.5]}{(174.0)} = 0.0431 > 0.0396$
- W40: $\theta > \frac{(\delta_{total} - \delta_y)}{\left(\frac{L}{2}\right)} = \frac{[9.25 - 1.10]}{(174.0)} = 0.0474 > 0.0420$

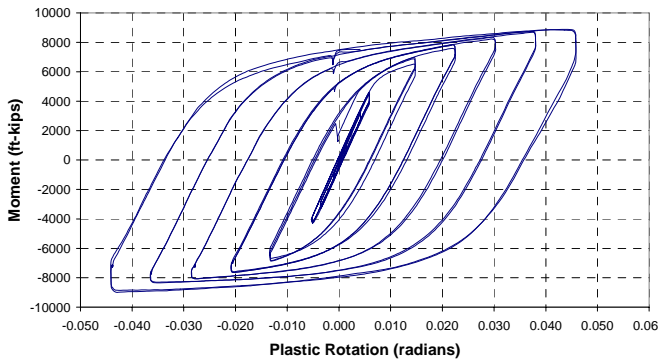
Figure 26. Moment-plastic rotation response of specimens 40-1 and 40-2 (rotation measured from the centerline of the column).
